Manhole Inspection Summary

Manhole # S69Y__009MH

Insp Date: **5/5/08 9:52 AM**

Location Address: **6400 Beckley St.**

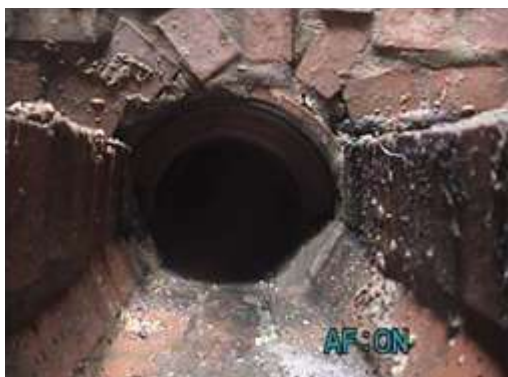
Defect 2

cracked pipe seal 1:00-2:00 outgoing 12 o'clock

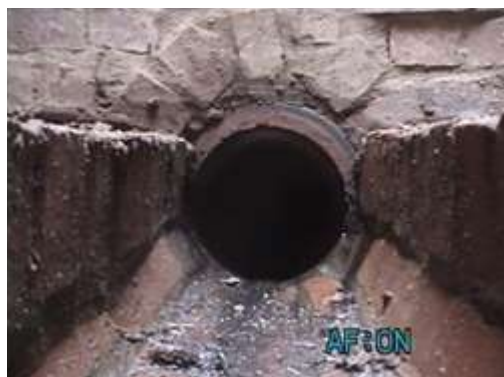
Defect 3

cracked pipe seal 11:00-2:00 incoming 6 o'clock

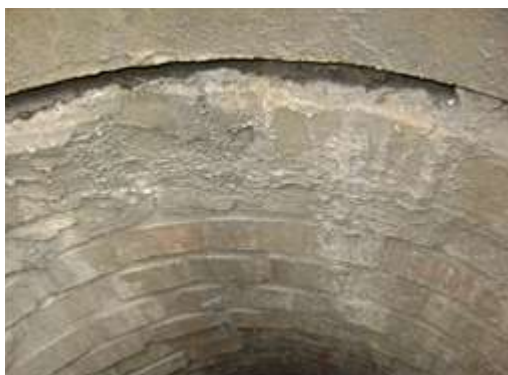
Defect 1

gap at frame seal

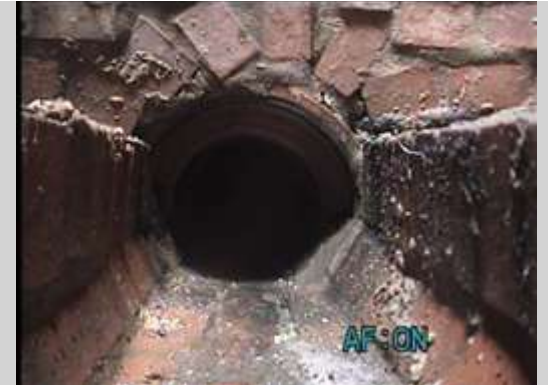
12 O'Clock Outflow

8 in. Circular Gravity Sewer
Pipe Out @ 12 O'Clock

Pipe Height: **9.6** (in.) Rod and Bar (Angled)
Pipe Material: **Clay** ☐ Pipe Lined
Invert Depth: **8.50** (ft.) Flow Characteristics: **Slow**
Deposits: ☒ None ☐ Mud ☐ Sludge ☐ Debris ☐ Grease
Silt Depth: (in.) Deposits Extent:
Infiltration: **None** Pipe Seal Cond: **Cracked**

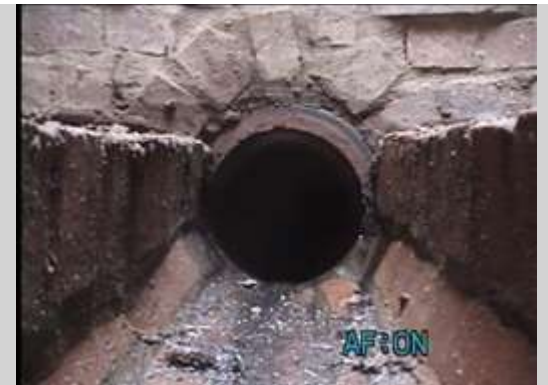
6 O'Clock Inflow

8 in. Circular Gravity Sewer
Pipe In @ 6 O'Clock

Pipe Height: **8.4** (in.) Rod and Bar (Angled)
Pipe Material: **Clay** ☐ Pipe Lined
Invert Depth: **8.17** (ft.) Flow Characteristics: **Slow**
Deposits: ☒ None ☐ Mud ☐ Sludge ☐ Debris ☐ Grease
Silt Depth: (in.) Deposits Extent:
Infiltration: **None** Pipe Seal Cond: **Cracked**
